Contract #: 04-0120F4Cty: SF/ALA Rte: 80 PM: 13.2/13.9File #: 69.28**WELDING INSPECTION REPORT****Resident Engineer:** Pursell, Gary**Address:** 333 Burma Road**City:** Oakland, CA 94607**Report No:** WIR-000100**Date Inspected:** 17-Mar-2007**Project Name:** SAS Superstructure**OSM Arrival Time:** 800**Prime Contractor:** American Bridge/Fluor Enterprises, a JV**OSM Departure Time:** 1530**Contractor:** Zhenhua Port Machinery Company, Ltd (ZPMC), Changxing Island **Location:** Shanghai, China**CWI Name:** Huang Wei**CWI Present:** Yes No**Inspected CWI report:** Yes No N/A**Rod Oven in Use:** Yes No N/A**Electrode to specification:** Yes No N/A**Weld Procedures Followed:** Yes No N/A**Qualified Welders:** Yes No N/A**Verified Joint Fit-up:** Yes No N/A**Approved Drawings:** Yes No N/A**Approved WPS:** Yes No N/A**Delayed / Cancelled:** Yes No N/A**Bridge No:** 34-0006**Component:** N/A**Summary of Items Observed:**

WELDING INSPECTION REPORT

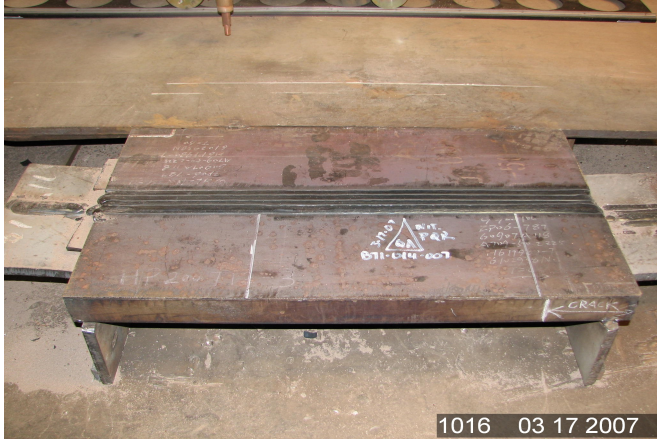
The CALTRANS Quality Assurance (QA) Inspector, Alfredo Acuna was present for the welding qualification testing pertinent for the welding qualification record (PQR) HP200712-3 scheduled for this project. ZPMC, welder operator Zhan Xing Jin was observed by the QA Inspector performing welding operations following the preliminary welding procedure specification PWPS-B-T-223(2)1T-1 for the PQR identified as HP200712-3. Base metal was designated as A-709-50-2/Z25 (Heat # 06102938N) and appeared to meet the non fracture critical impact test requirement. The root opening of the joint was approximately 6 mm. ZPMC followed AWS 5.13 the production procedure WPS using the automatic submerged arc welding (SAW) process in the flat (1G) position with the 4.8 mm diameter EH-14 electrode (Dual process PQR/FCAW and SAW). The QA Inspector verified amperages, voltages, travel speeds, preheat and heat interpass temperatures. The QA inspectors recorded welding parameters for a total of 6 passes. The QA inspectors observed that the welding parameters taken by ZPMC QA inspector Hu Gang appeared to be accurate and in accordance with the contract documents. ZPMC QC (CWI) Huang Wei witnessed the testing and performed visual weld inspections. The PQR HP200712-3 was completed on this date. The QA inspector issued the lot # B71-014-007 after completion.
